Subject: Platoon Early Warning System Report of Test and Evaluation 9860-0003

## PLATOON EARLY WARNING SYSTEM DEVELOPMENT PROGRAM DETECTOR CONSISTENCY

## PREPARED FOR THE MILITARY ELECTRONICS STRATEGIC BUSINESS UNIT ISC TECHNOLOGIES INC.

PREPARED BY BRUCE WALTERS

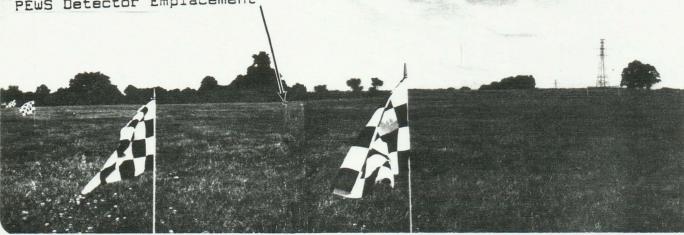
Figure 2.1 Field Test Site: Lancaster County Park

The detectors were placed in a long trench and enveloped with soil (Figure 2.1). Care was taken to ensure that all of the detectors were equally emplaced. A number of tests were performed under similar weather conditions and using the same person as a target (Appendices J and K). The detectors were placed in a different order each time, to avoid the possibility of seismic channeling allowing some detectors to receive the seismic wave while preventing the others.

PEWS Detector Emplacement

Buried Detectors

In order to validate the modification, tests were performed again at Lancaster County Park, exactly as described in section 2.1. The detectors were placed in a long trench and enveloped with soil. Care was taken to ensure that all of the detectors were equally emplaced. A number of tests were performed under similar weather conditions and using the same person as a target (Appendices J and K). The detectors were placed in a different order each time, to avoid the possibility of seismic channeling allowing some detectors to receive the pressure wave and preventing others from receiving it.

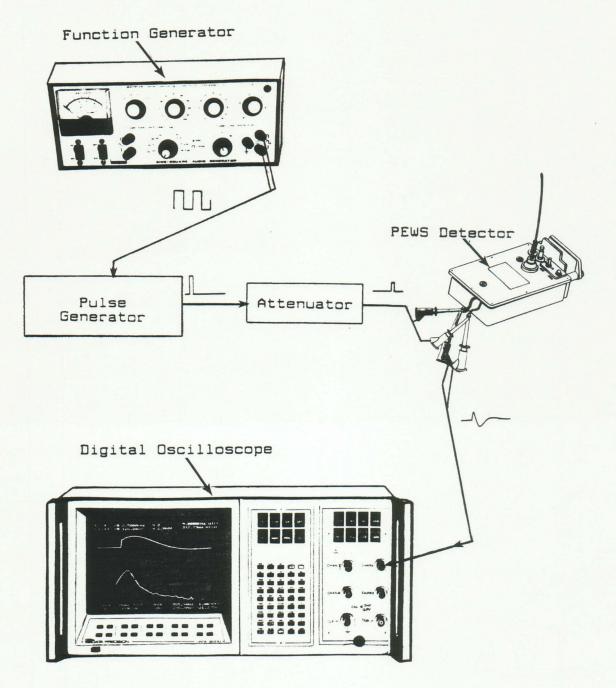
Figure 2.2 Test Equipment Configuration, Geophone

A pulse generator was constructed to provide a 5-volt, variable duty cycle, square-wave pulse. The test equipment was configured as in Figure 2.2. A square-wave, from the function generator, was used to trigger the pulse generator. A pulse, one millisecond in duration, was fed to the geophone through an attenuator. The geophone response was monitored by a digital oscilloscope. This response (to the pulse) was then processed (using functions on the digital oscilloscope) to determine the frequency response of the geophone.

The response of all of the geophones was similar, both in signal level and frequency-related properties. The geophones were working exactly as expected; therefore, the geophones could be eliminated from suspicion.

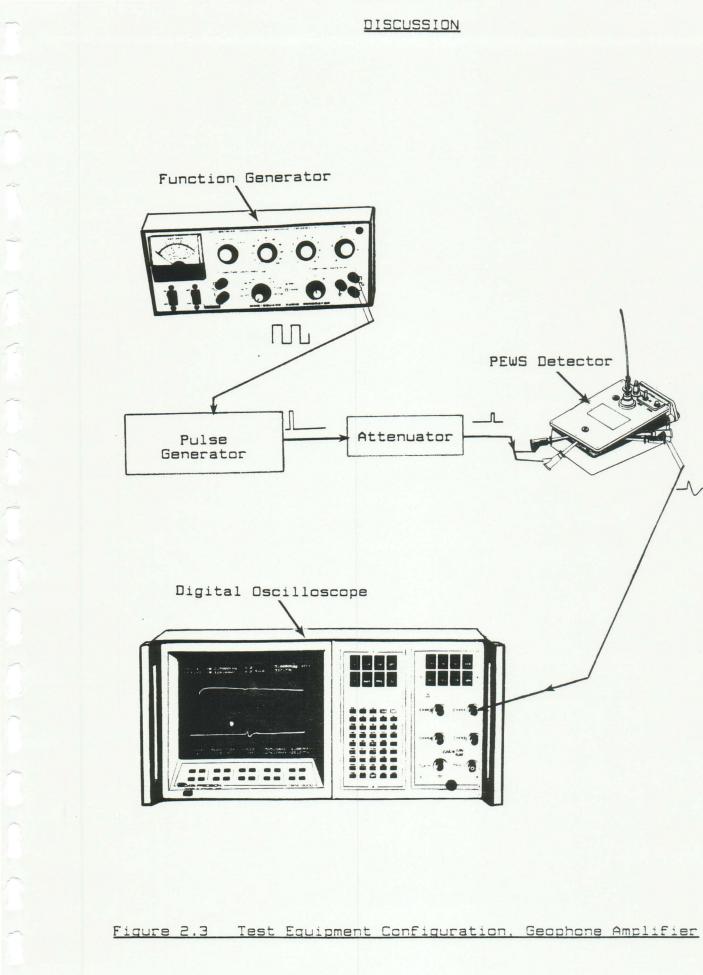
Next, the schematic for the geophone amplifier section was carefully studied. The equipment was configured as in Figure 2.3. The geophones were disconnected and a resistor (330 Ohm) was installed in each of their places. These load resistors emulated geophones that were free of frequency coloration. Again, the function generator provided the triggering square-wave for the pulse generator. The one millisecond pulse was fed to the amplifier through an attenuator. The response of each seismic amplifier at any given Automatic Gain Control (AGC) voltage was different from any other seismic amplifier.

Further investigation showed that the only physical difference between the detector amplifiers was a resistor in the AGC loop. This resistor, selected at test during manufacturing calibration, became the focus of our investigation. The resistor in question affects the gain of the AGC amplifier. The gain should be the same for each detector. If the gain is not the same for each detector, then each detector will perform differently from any other. Changing the value of this resistor has no desirable effects on detector circuit performance. All of the detectors should have the same value for this resistor. The resistor value should be chosen so that the AGC amplifier exhibits a gain that is usable under realistic operating conditions.

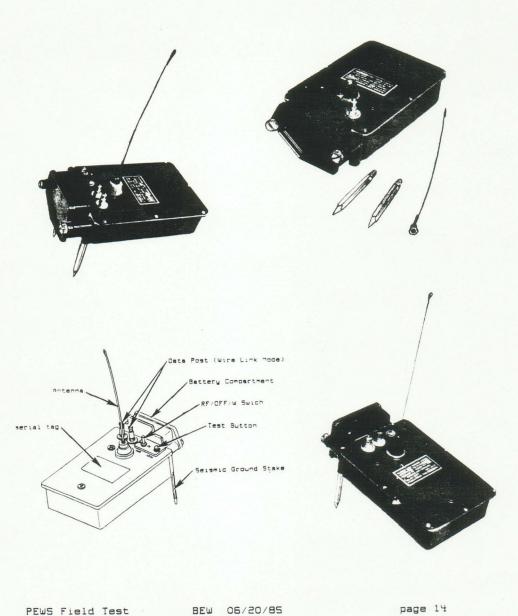
Figure 4.11.2 PEWS Detector (ground sensor)

5.2 Figure 2 PEWS Detector (ground sensor),

DT-577(U)/TRS-2(U)

Physical: Dimensions (Inches): Length 6.6 Width 3.8 Height 2.5 Weight (Pounds): 1.14 (with battery) Volume (Cubic Inches): 29.6 Operation: Power/Mode Switch: toggle RF/OFF/WIRE Test Switch: Push to Test Code Plug (Programmable): Identification Number: 1 to 16 Area Number: 1 to 8 Parity: On or Off Operating Temperature Range: -31 to +71 Degrees Centigrade -25 to +160 Degrees Fahrenheit Power Consumption: 1.0 mA in Standby Mode 200 mA in Transmit Mode Stabilization Time: 5 Minutes after turn on Detector Range: 10 Meters Detection Capability: Detect and Classify Personnel and Vehicles Sensor Type: Seismic: Geophone

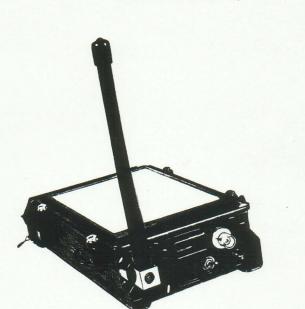
5.3 Figure 3 PEWS Receiver (receiver/monitor),

The PEWS receiver/monitor (see Figure 3) acquires the message through a) the Wire Link Module (via field wire), which would be attached to the receiver when the Wire mode is selected, or b) the radio receiver section (via radiated (RF) energy and antenna) when the RF mode is selected. Intrusion detection is indicated by an audible tone and the light emmiting diode (LED) display. The LED display registers the detector identification number and the type of detection for each originating detector in the network. Updated intrusions are also indicated and will be held in memory until the receiver/monitor is reset by personnel.

- 3.2.8 Install the receiver antenna adapter securely in the antenna socket, located on the top of the receiver. Install the receiver whip antenna stably in the antenna adapter, located on the top of the receiver. Repeat for each receiver (see 2.1.1  $\,$ and Figure 3).

- 3.2.9 Turn all of the detectors and receivers on, selecting the RF mode of operation unless otherwise requested (see 2.1.1, Figure 2, and Figure 3).
- 3.2.10 Set all of the receivers to the same area code as the detectors (see 2.1.1 and Figure 3).

- 3.2.11 Push the TEST button on the detector, wait a few seconds, and observe the proper ID number on the receiver display. The number displayed should be the same as the ID number on the detector label. If you do not read the proper ID number on the receiver, check the ID plug for the correct ID code (corresponding to the label), check the 9 volt battery, or discard the detector as reject, subject to later intensified testing. Repeat for each detector and receiver (can be performed simultaneously on receivers) (see 2.1.1, Figure 2, and Figure 3).

- 4.5.1 Turn off and remove the batteries from the detectors and receivers (see 2.1.1 , Figure 2 and Figure 3).
- 4.5.2 Turn off the RF data link and optional test equipment, if utilized. Disconnect the RF data link transmitter from the detector and the RF data link receiver from the recording/reading equipment if employed. Prepare all test-related equipment and ancillaries for transportation (see 4.4).
- 4.5.3 Remove the detector antenna from the detector, and store the antenna in one of the canvas carry bags. Repeat for all detectors (see 2.1.1 and Figure 2).

- 4.5.6 Remove the receiver antenna from the receiver/monitor. and store it in one of the canvas carry bags. The antenna adapter may remain on the receiver/monitor. Repeat for all receivers (see 2.1.1 and Figure 3).

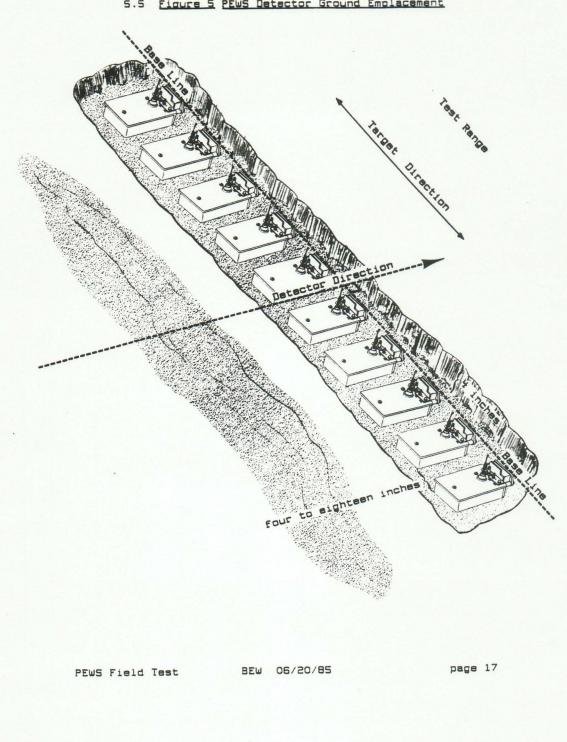
Figure 4.11.5 PEWS Detector Ground Emplacement

5.5 Figure 5 PEWS Detector Ground Emplacement

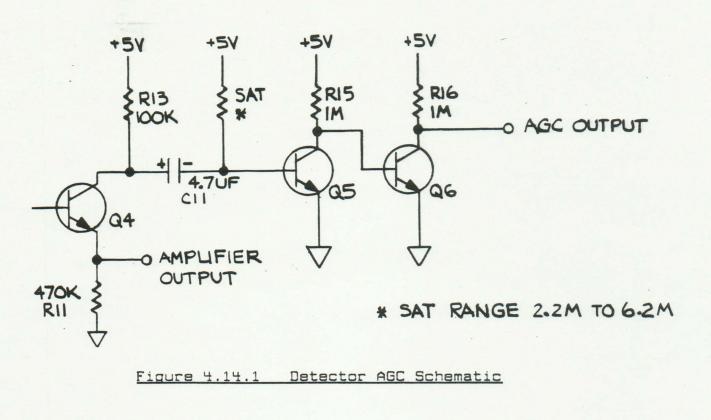
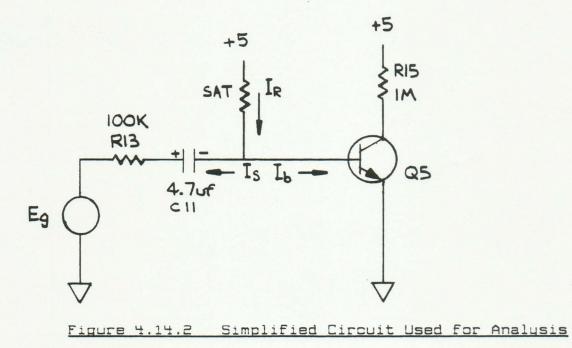
- Q<sub>6</sub> will switch very rapidly (as Q<sub>5</sub> switches) therefore only switching conditions for Q<sub>5</sub> will be considered.
- 3. For analysis purposes (we are going to determine the relative impact of changing  $R_{SAT}$ , the Select At Test resistor, not absolute switching voltages)  $R_{13}$  will be ignored.

- 5. Frequency of interest is 15Hz.
- 5. AGC action starts when the incoming signal is just large enough to turn  $Q_{\rm S}$  off.

$Q_{S}$  is off when  $I_{R} = 0$  ,  $V_{BE} = 0$ Conditions at Q5 are: IR = <u>SV</u> RSAT Is =  $C \frac{dE}{dt}g$ If  $E_{\sigma} = A \sin(\omega t)$ Then  $\frac{dE}{dt} = A w \sin(wt)$ For IB = 0 IR = IS peak  $\frac{5}{R_{SOT}} = C_{11} (A \ w \ \cos \ (WT))_{wt} = 0$  $\frac{5}{R_{SOT}} = C_{11} A w$ At 15 Hz,  $\omega$  = 2 pi f = 6.28(15)  $A = \frac{5}{4.7 \times 10^{-6}(6.28)(15)R_{SAT}}$  $A = \frac{5 \times 10^{6}}{(442.74)R_{SAT}} = \frac{1.13 \times 10^{4}}{R_{SAT}}$ For R<sub>SAT</sub> = 2.2 megohms A = 5.1 mV (peak) For R<sub>SAT</sub> = 6.2 megohms A = 1.8 mV (peak)

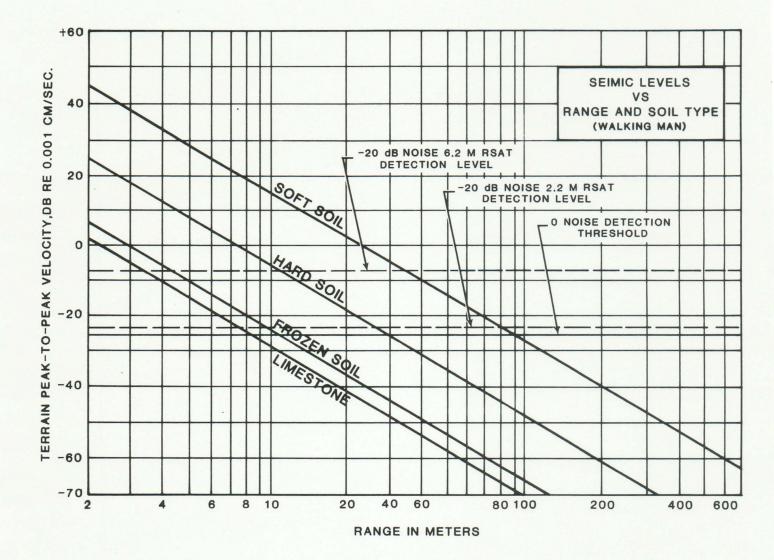
Figure 4.14.4 Seismic Levels vs Range and Scil Type

This noise level is a very quiet seismic environment. At all noise levels higher than this, PEWS detectors with 2.2 megohm  $\rm R_{SAT}$  will have a substantial advantage over those with higher values of  $\rm R_{SAT}$ . Figure 4.14.4 illustrates the difference in range caused by  $\rm R_{SAT}$  for a target of 1 man walking on various soil types.
